2021 Cardioplegia

Category: cardioplegia

Incident type: Good Catch Near Miss

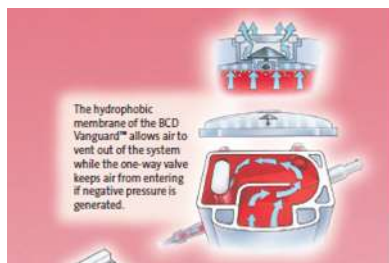
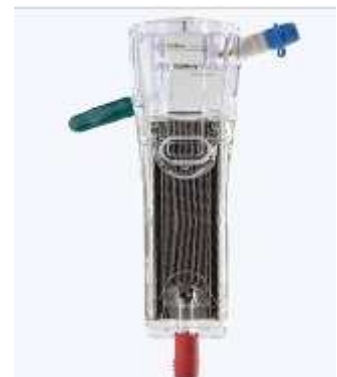
Description: Our unit recently introduced the Sorin (dideco) Vanguard heat exchanger into our cardioplegia circuit. We have been using this device for a number of months without any trouble. During this incident, after 2 uneventful doses of cardioplegia and prior to the 3rd dose of cardioplegia, air was noted in the vanguard device, in fact it had de-primed itself all the way down to the patient delivery line. The surgeon had to disconnect the delivery line and allow us to purge the air prior to our next dose of cardioplegia. If the air had not been noticed, it would have been delivered down the coronary arteries. At the end of the case, the vanguard device was tested and air was noted within the device at all pressures less than -50mmHg. Subsequently we have tested other Vanguard devices and it seems that this is true for Vanguard devices in general. The (so-called) one way valve/priming valve, at the top of the unit, allows the device to be primed quite easily however does allow air back into the device at negative pressures we have not, in the past, been concerned about. The company suggested clamping the delivery line after the delivery of cardioplegia and prior to venting the heart. The negative pressure is generated by the venting of the ascending aorta by the [dual lumen antegrade cardioplegia cannula] vent. Currently we have a one way valve in our vent line which prevents negative pressures less than 110 mmHg to be transmitted through the circuit. This seems to be enough to prevent cavitation but not enough to prevent air from entering the Vanguard.

Commentary Surprisingly, this problem has not been previously reported to PIRS. The editor could find no IFU caution regarding air entrainment from the one way valve designed to "keep air from entering if a negative pressure is generated." The company advice to clamp the cardioplegia delivery line after administering cardioplegia to prevent the problem suggests that this is a design issue rather than an isolated device or a batch issue (that would generate a recall). PIRS Ed

Preventive actions Knowledge of the incident and increased awareness of the limitations of the Vanguard heat exchanger has been widely circulated within our group. Clamping the cardioplegia line prior to venting the heart has been advocated and is now my standard practice
