## 2021 Coagulation - oxygenator changeout

# Parallel replacement of the oxygenator that is not transferring oxygen: the PRONTO procedure

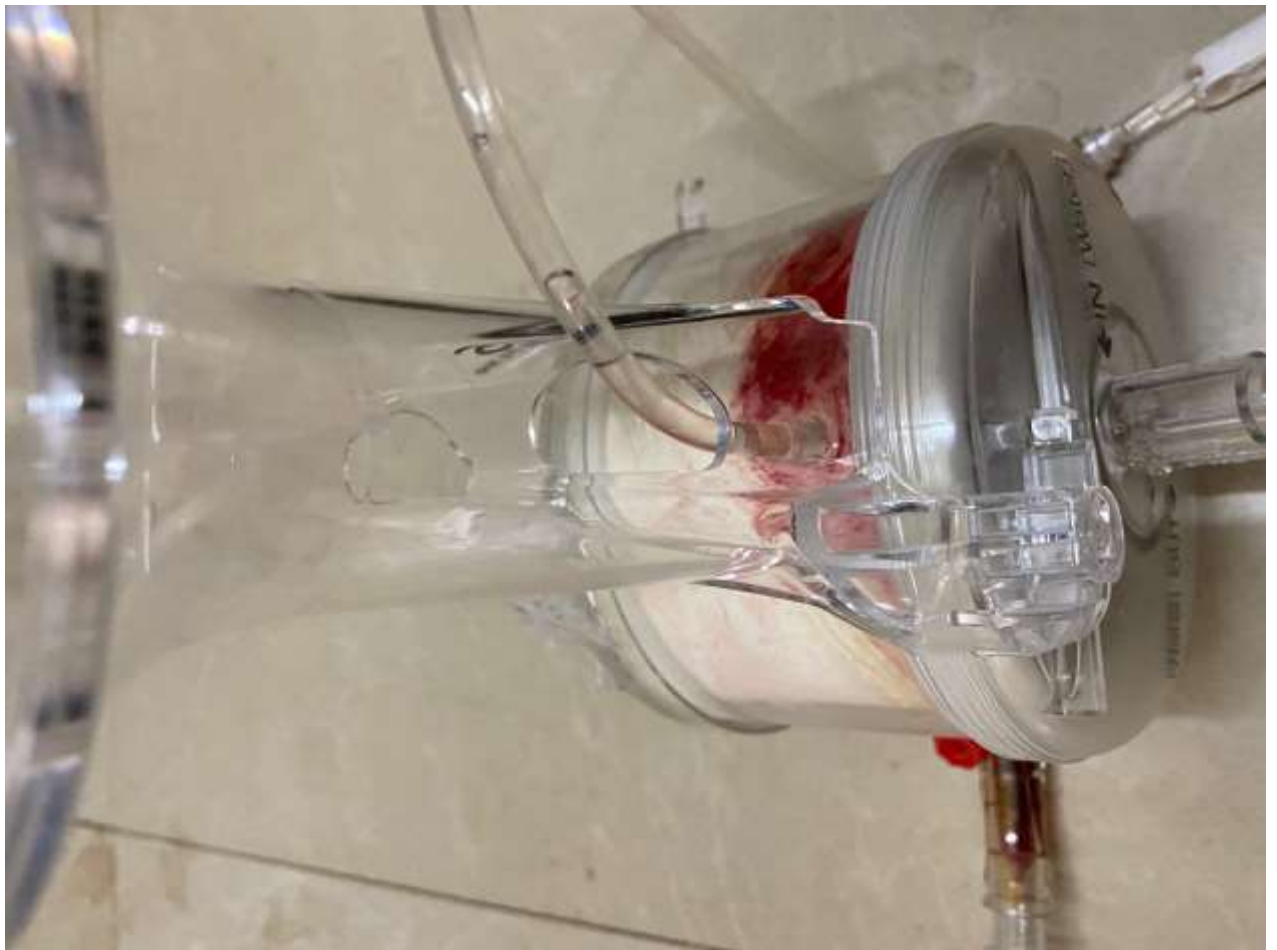
Permission to print:	Yes
Category	Coagulation
Incident type	Good Catch No Harm Incident
Duration of incident:	minutes
Description:	<p>Patient 39 YO male Ht 175cm and weight 58.5 KG with a history of RHD, S/P balloon MV valvuloplasty. Procedure AVR and MVR with CPB. The circuit consisted of a Sorin S-3 roller pump, Sechrist gas blender, Terumo FX15 oxygenator and Terumo custom tubing pack with X coated tubing set with 3/8 - 3/8" ID AV loop and a 1/2" ID boot. Monitoring consisted of a Specturm M-4 Viper monitor. The patient was heparinized with 300u/KG of unfractionated heparin. The post heparin ACT was 435sec. Since there was 10,000u of heparin in the prime we proceeded to CPB. After initiating CPB the flow was increased to 4.2l/min. The PaO2 was 136mmHg with 100% FiO2. ? This was lower than expected, Our center is located 6300ft above sea level and our hospital oxygen system consists of an oxygen concentrator system. Often our wall oxygen is between 82-95%. I had set my Flo2 at 100% but at that time the Oxygen Concentrator was put out 80-85%. The PO2 increased with cooling to 32C. As cooling proceeded the PaO2 increased to 180mmHg. The initial post membrane line pressure was 195 mmHg. Fifteen minutes after the heart was arrested with 1,000 ml of Del Nido Cardioplegia, it was noted that the post membrane pressure dropped to about 150mmHg and there was a blood leak at a connector before the oxygenator. The pre membrane pressure was measured and found to be approximately 600mmHg. (Trans membrane pressure ~450, should be 100-140). Additional 10,000 units of heparin was administered (subsequent ACT492). A change out in this case was decided primarily due to high pressure excursion. I thought the circuit would explode if we continued. Oxygenation was a marginal secondary problem The membrane was changed without coming off bypass using the PRONTO Technique. Our circuit has a 3/8 bridge around the oxygenator. The pre and post membrane pressure can be measured from LL connection by simply moving a clamp. An inspire 6 oxygenator was added to the circuit. The post membrane pressure increased to 220mmHg and the PaO2 increased to 400mmHg. After CPB the first oxygenator was rinsed and inspected. There was high resistance across the oxygenator and visible clot seen in the fiber bundle.</p>

Washed out oxygenator showing clot

GOOD CATCH - what went well	<p>The surgeon and anesthesia team was informed about the problem. The PRONTO bridge in our circuit allowed us to check both pre and post membrane pressure. The second oxygenator could be added to the circuit without coming off bypass. There was no interruption of blood flow to the patient or signs of lactic acidosis. We have used a PRONTO bridge in our circuit for every procedure.</p>
What could we do better	<p>Administered more heparin when the initial ACT was less than 480sec. This patient had double valve disease and a presumably higher blood volume. Checked the pre membrane pressure and lower PO2 pre X clamp.</p>
Preventive actions	<p>We might have considered loading with 400u/KG of heparin. A formal check that perfusion is all ok including the pre membrane pressure before aortic cross clamps applied.</p>
Hospital incident filed:	No
Ext Authority Advised	No
Rule issue	Yes
