2021 Heater Cooler Degradation

Permission to print:	Yes
Category	Heater Cooler unit
Incident type	Good Catch No Harm Incident
Type of incident:	Equipment
Duration of incident:	minutes
Description:	<p>Prolonged CPB (CABG BSA 2.18), Inability to rewarm large patient when asked to by surgeon [using a] 3T HCU, Inspire8 oxygenator, Maquet HL20 HLM. During bypass when asked to rewarm the patient by the surgeon to a normothermic state the perfusionist set the 3T to 38C. The patient n/p temperature was 33.4C but the recorded arterial blood temperature measured at the oxygenator only achieved 34.7C. Inspection of HCU hoses confirmed (some) flow was present from 3T HCU to heat exchanger. As the blood temperature was not the expected temp for the setting on the HCU, the HCU hosing was disconnected and coupled on itself to check the HCU flow and heating performance and correct HCU performance was confirmed. The HCU lines were reconnected to oxygenator and rewarming recommenced with no change to the blood temperature. Connection of the cardioplegia heating hoses to the oxygenator to see if this warmed the blood was without effect despite setting the temperature at HCU to up to 40 (patient side

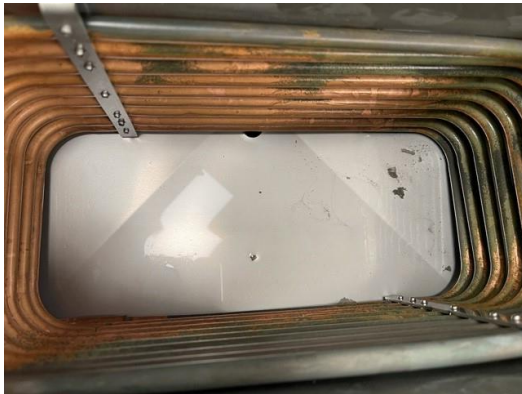
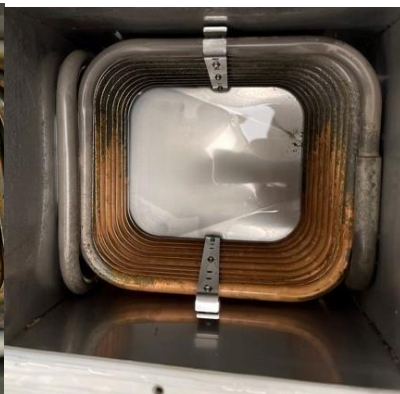
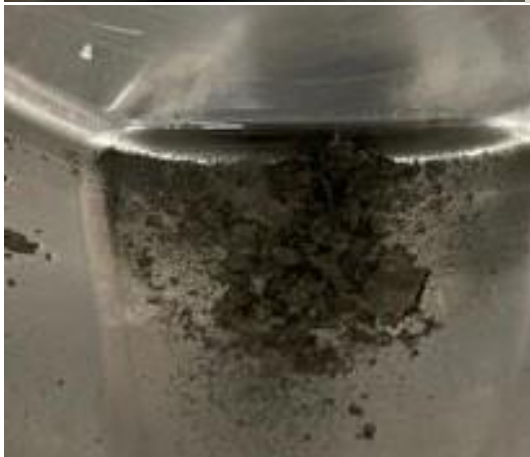
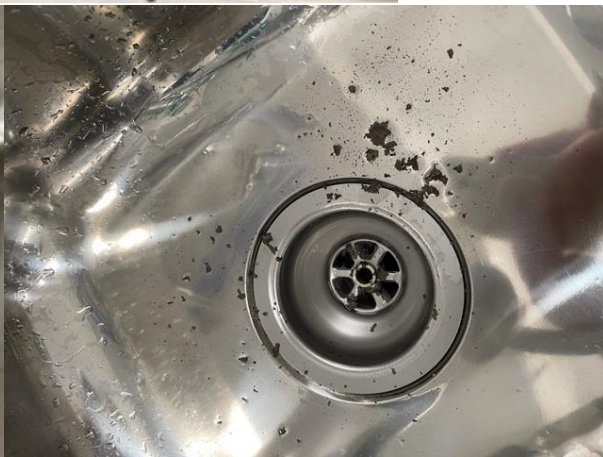
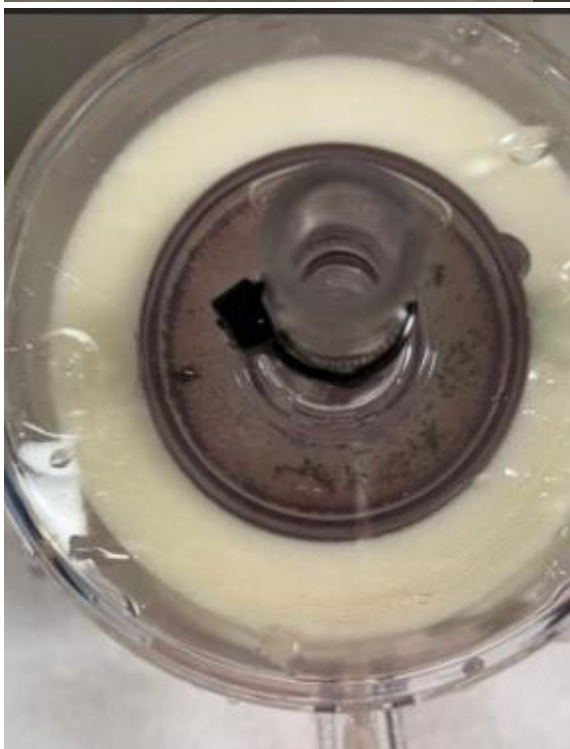
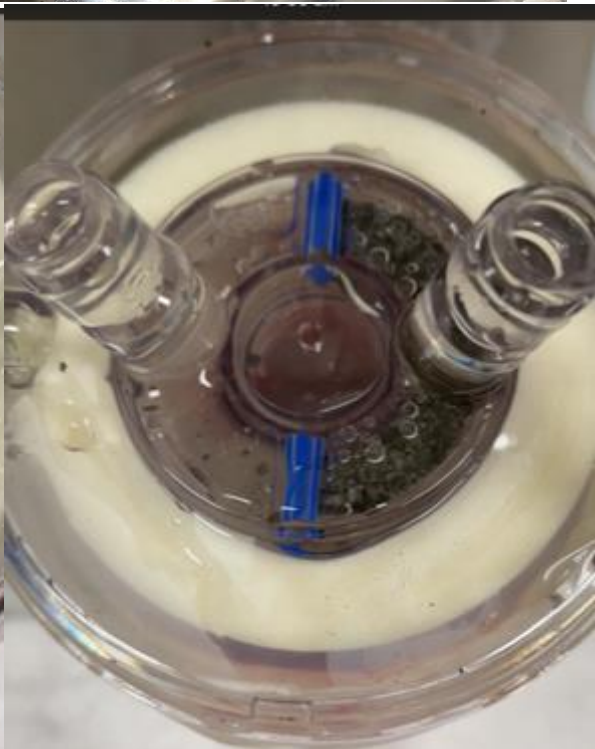
Commentary Problems of degradation of the 3T HCU after disinfection has been previously documented (1) but the PIRS2 is not aware of an associated failure of a heat-exchanger. This occurred with the users strictly following the IFU for decontamination. Given the ubiquitous use of the 3T HCU in Australasia and elsewhere and the mandatory compliance with decontamination readers should be observant for signs of 3T HCU degradation. PIRS2 Ed. (1) Sgarvey MI, Bradley CW, Walker J. A Year in the Life of a

Photos of the 3T HCU particulates from the device used in the oxygenator heat-exchanger failure incident

Preventive actions Check for particulates in the water hoses. Daily water changes. Confirmation via email that the IFU cleaning says the same at present email from company.
