2021 Oxygenator 2

Category Oxygenator

Incident type Good Catch Near Miss

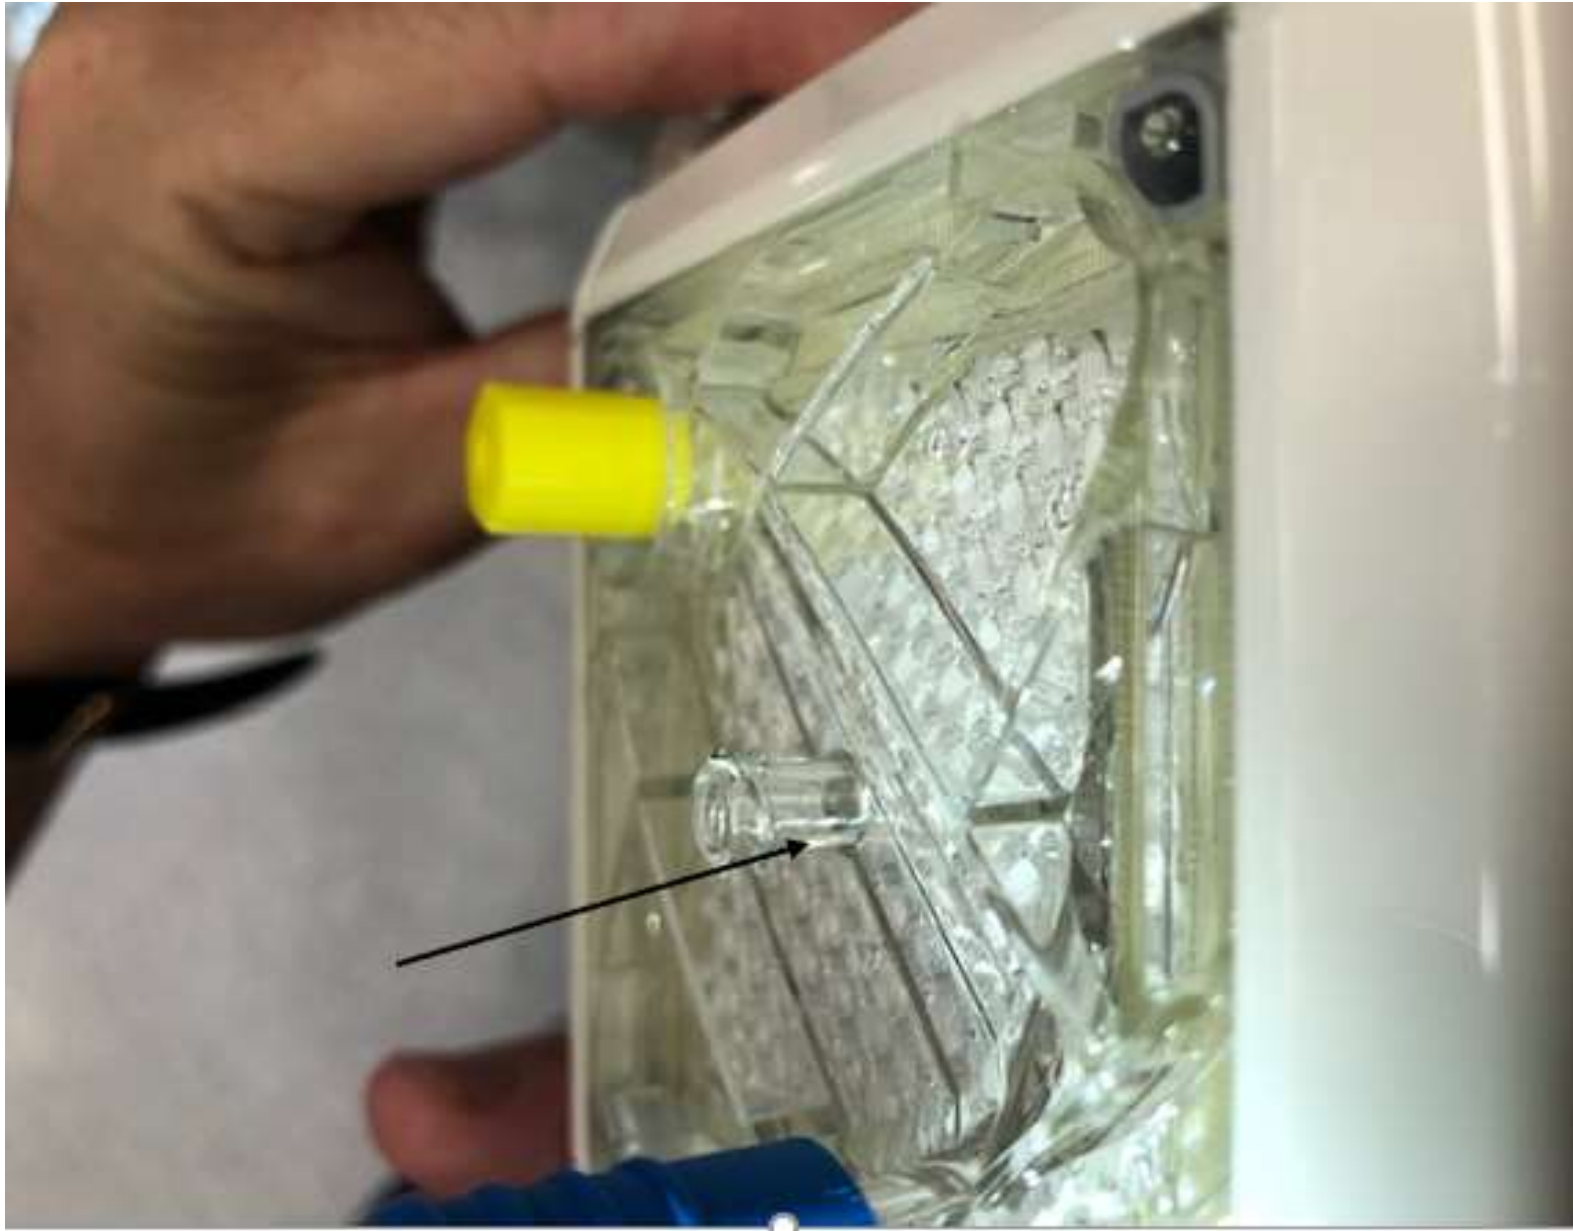
Leak from luer lock on the inlet side of Ref BO-HQV 141400 neonatal oxygenator Getinge group, identified during priming. It was a relatively slow leak which was not identified when the occlusion was checked, and with a crystalloid prime any small drops on the floor would have been difficult to identify. The leak was identified when albumin was added and a small drop of yellowish fluid was observed on the floor. Oxygenator changeout was performed and on examination of the 2nd oxygenator a similar crack on luer casting was noticed. This was "Bench" pressure tested and the same leak was identified, the oxygenator /reservoir were of the same batch. A 3rd oxygenator was opened with a different batch, visibly examined and looked intact. This was then placed with the primed circuit. Surgery continued without issue. Original product: Leaked during priming. Ref BO-HQV 141400, Lot 3000166932, manuf: 26/04/2021, exp 26/04/2023. Oxy lot: (blue sticker) 3000147605, reservoir lot: (silver sticker) 3000156399 BO-02950. 2nd Oxygenator (not used as crack identified before placement): Ref BO-HQV 141400, lot:3000166932, man:26/04/2021, exp 26/04/2023. Oxy lot Blue(blue sticker) 3000147605, reservoir lot:(silver sticker3000156399- not required).

GOOD CATCH - what went well Attention to detail. The leak was identified when albumin was added (small drop of yellowish fluid was observed on the floor), this could easily have been misinterpreted as condensation from the exhaust port. Further examination showed a hairline crack on the luer casting, the luer lock cap which came with the oxy was replaced with a "Braun " combi -stopper, the leak was significantly more obvious then. The vigilance of the operator and the use of a lamp positioned on the oxy. port. A thorough examination of the 2nd oxy above what would normally be expected particularly being the same batch including pressure testing using Plasmalyte 148. Good communication was made to delay anaesthesia induction until problem was sorted. (only 1 other oxygenator was available and if there had been an issue it would have meant changing to a different device with a blood prime required).

Preventive actions Thorough examination of luer castings on that particular equipment planned, both leaking oxy returned to manufacturer for examination
