# 2022 Oxygenator - leak

Category: Oxygenator

Incident type: Good Catch Near Miss

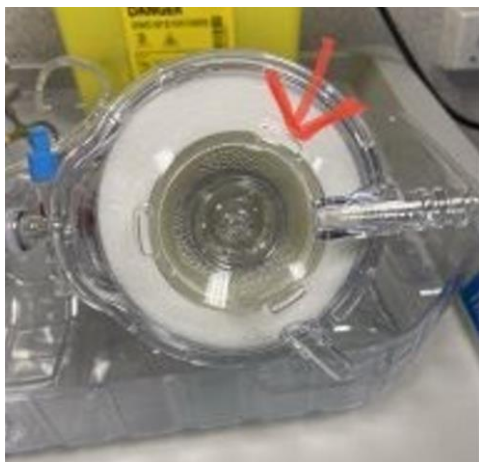
Description: During priming for a cardiac case in theatre using the Terumo System One and the Medtronic Fusion oxygenator, it was noticed that there was a puddle of clear fluid under the oxygenator. We routinely attached our heater cooler water lines to the dry setup circuit to test for leaks prior to priming. It was assumed the puddle on the floor was from the water lines [rather than the oxygenator] so they were drained and connections checked. The connections were then doubled checked and refilled the water lines to see the leak was still under the oxygenator. I dried the floor and oxygenator and then took the water lines completely off. The oxygenator was still leaking. A nurse confirmed that she also noticed the leak. The fluid was coming from the gas vent at the base of the oxygenator (see photo)./ The decision was then made to change out the oxygenator which was done with no problem. The new oxygenator was used without incident.

Commentary: Oxygenator fibre leaks are rare and usually minimal with reports where this has become apparent during the procedure but changeout has not been required as adequate function has been maintained. This good catch describes a "puddle" and continuing leak during priming that suggests a significant leak fortuitously picked up prior to CPB. PIRS Ed

Preventive actions: The oxygenator is being returned to the manufacturer for investigation. change to the current setup or timing of priming
