2023 Circuit Disruption

URGENT - PRODUCT DEFECT ALERT

Affinity Fusion™ Oxygenator

Temperature Monitoring Adapter

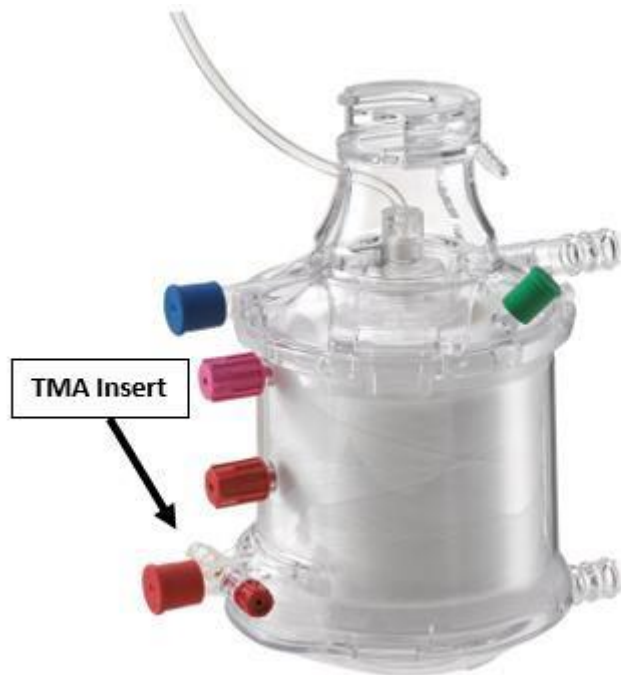
The complaints indicate that the TMA (see Image 1 for the TMA location) had come loose from the oxygenator either during pre-procedure perfusion set-up or post-procedure when disassembling the perfusion circuit.

Image 1 – TMA location on the Affinity Fusion Oxygenator

Since 02 August 2021, there have been 83 complaints globally, with 1 in Australia, of TMA separation from the oxygenator, with 70 reported from 07 November 2022 to 26 January 2023. The investigation to date indicates reduced connection strength for TMA connections made in the past 17 months, resulting in detachment prior to or after the procedure. In all instances, the TMA separation only occurred pre- or post-procedure, and there were no adverse patient impacts reported. To date, no TMA events have been reported during a procedure.

The potential harms related to the TMA detaching during use are: infection (contamination due to handling of TMA), neurological dysfunction (reversible), neurological dysfunction (irreversible), hypovolemia, and exsanguination. Medtronic is providing device use recommendations (below) to minimize TMA loosening or detachment. Medtronic is finalising the root cause investigation and will take appropriate actions as warranted.

- Continue to use Affinity Fusion Oxygenator and the TMA for arterial temperature monitoring. Ensure there is minimal torque applied to the oxygenator TMA when attaching or detaching the temperature probe (Product Number ATP210). Also minimise manipulation of the TMA probe connection during the clinical procedure.
- Complete the enclosed Customer Confirmation Form, acknowledging that you have received this information, and email to rs.anzrecalls@medtronic.com.
- This notice must be passed on to all who need to be aware within your organisation or to any organisation where the potentially affected devices have been transferred.

If the TMA becomes detached before the procedure setup or priming, discard the product. If the TMA becomes detached during the procedure and an oxygenator replacement is decided, follow the Instruction for Use, Emergency Oxygenator Replacement section. If the TMA becomes detached after the procedure completion, no additional action is required.

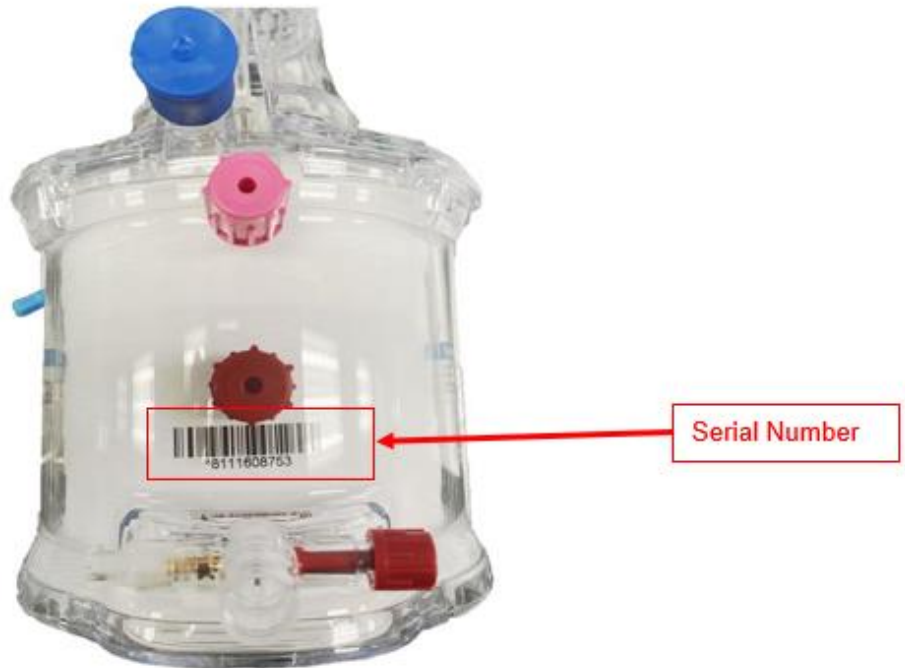
Image 2 - SN location on the Affinity Fusion Oxygenator

At time of set up, locate the serial number on the affected product by referring to the image below.

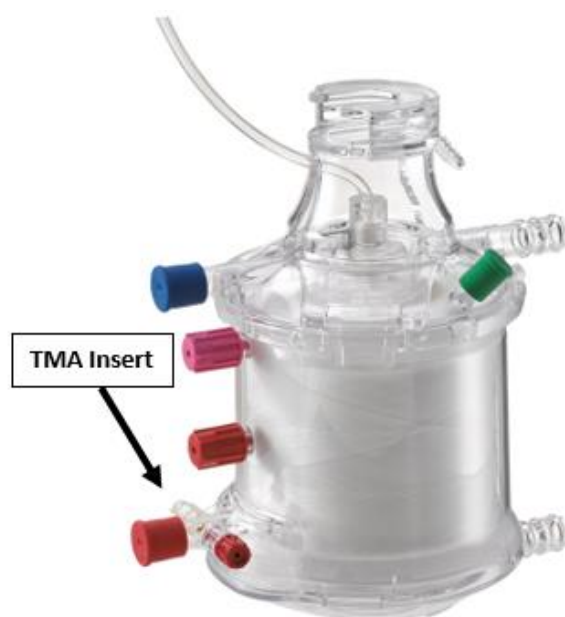
The complaints indicate that the TMA (see Image 1 for the TMA location) had come loose from the oxygenator either during pre-procedure perfusion set-up or post-procedure when disassembling the perfusion circuit.

Image 1 - TMA location on the Affinity Fusion Oxygenator

Since 02 August 2021, there have been 83 complaints globally, with zero in New Zealand, of TMA separation from the oxygenator, with 70 reported from 07 November 2022 to 26 January 2023. The investigation to date indicates reduced connection strength for TMA connections made in the past 17 months, resulting in detachment prior to or after the procedure. In all instances, the TMA separation only occurred pre or post-procedure, and there were no adverse patient impacts reported. To date, no TMA events have been reported during a procedure.

The potential harms related to the TMA detaching during use are: infection (contamination due to handling of TMA), neurological dysfunction (reversible), neurological dysfunction (irreversible), hypovolemia, and exsanguination. Medtronic is providing device use recommendations (below) to minimize TMA loosening or detachment. Medtronic is finalising the root cause investigation and will take appropriate actions as warranted.

Option 1: Continue to use the Affinity Fusion Oxygenator without using the TMA - use other conventional perfusion circuit temperature monitoring methods; or

Option 2: Continue to use the Affinity Fusion Oxygenator and the TMA for arterial temperature monitoring. Ensure there is minimal torque applied to the oxygenator TMA when attaching or detaching the Temperature Probe (Product Number ATP210). Also, minimise manipulation of the TMA-probe connection during the clinical procedure.

If the TMA comes detached before the procedure setup or priming, discard the product. If the TMA comes detached during the procedure and an oxygenator replacement is decided, follow the Instruction For Use, Emergency Oxygenator Replacement section. If the TMA comes detached after the procedure completion, no additional action is required.

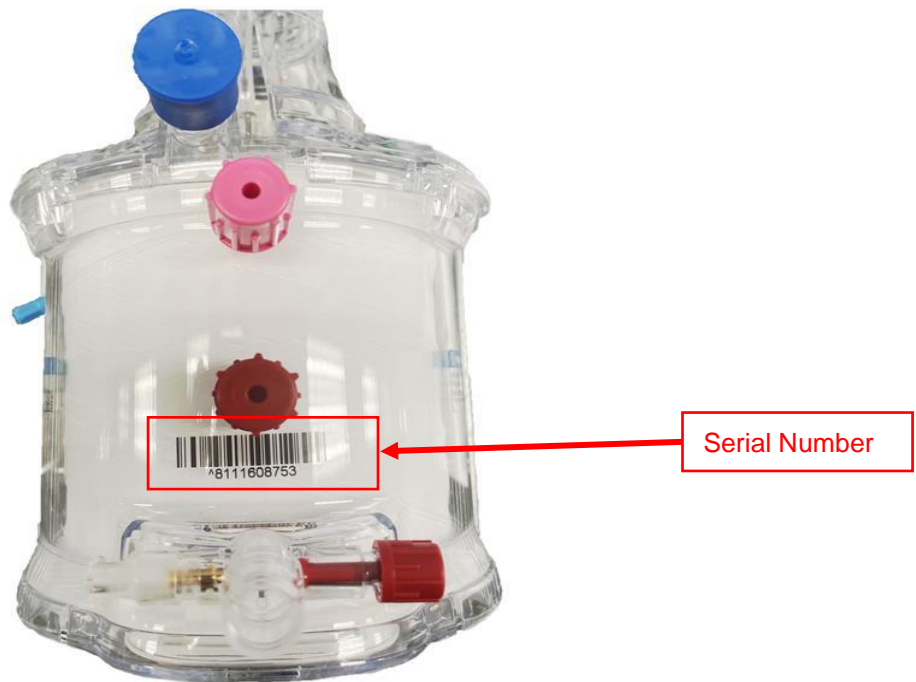
Image 2 - SN location on the Affinity Fusion Oxygenator

At time of set up, locate the serial number on the affected product by referring to the image below.
