2024 Gas supply (Vaporizer)

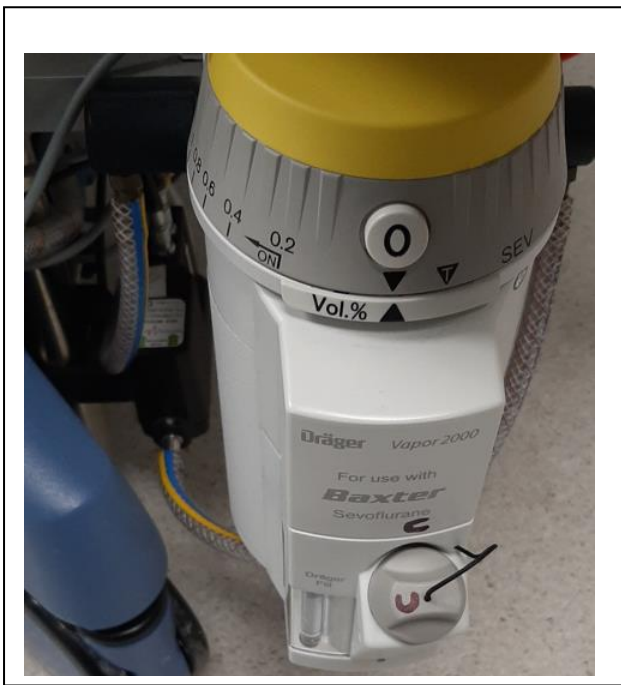
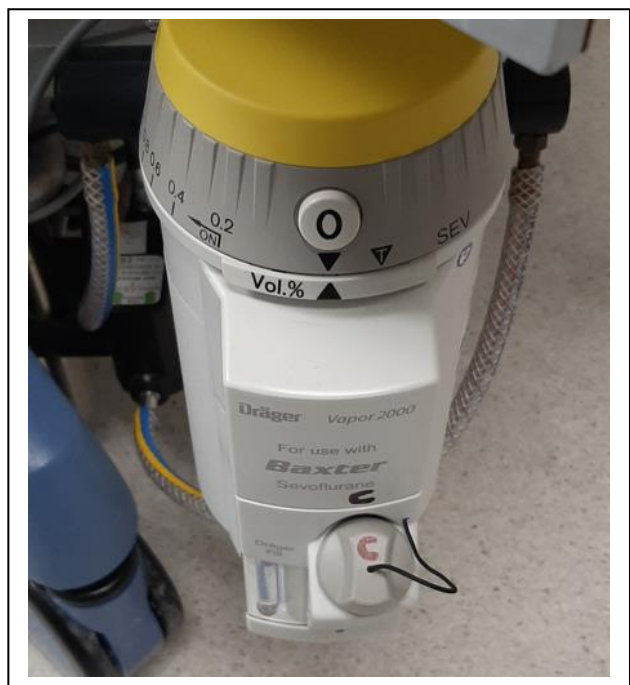
Reports of loss of gas supply to the oxygenator due to vaporizer leak are not uncommon. However, this is the first report to PIRS2 due to the position of the filling cap on a sevoflurane vaporizer. The simple preventive measure of marking up the cap position illustrated in the attached photos provides an effective preventive measure that should be incorporated in the device design.
