2026 Circuit Disruption (Centrifugal pump)

Permission to print: Yes
Category: Circuit disruption
Category 2: Centrifugal pump
Severity: Good Catch Near Miss

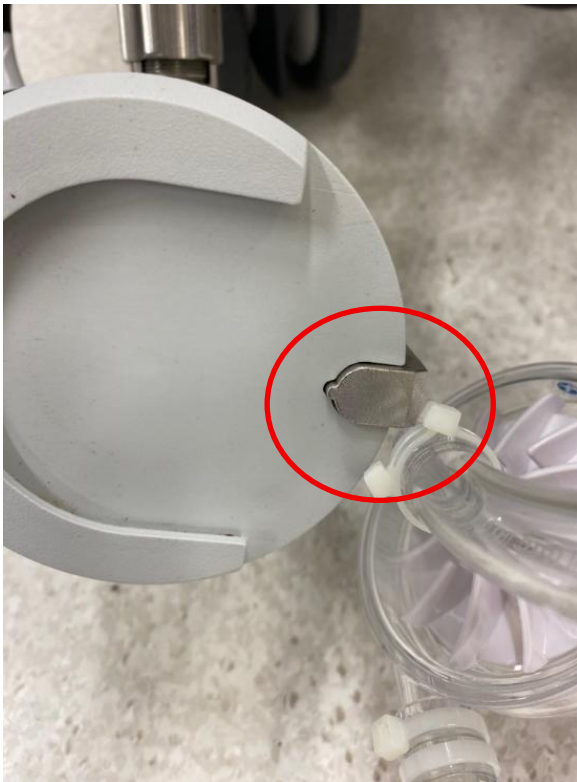
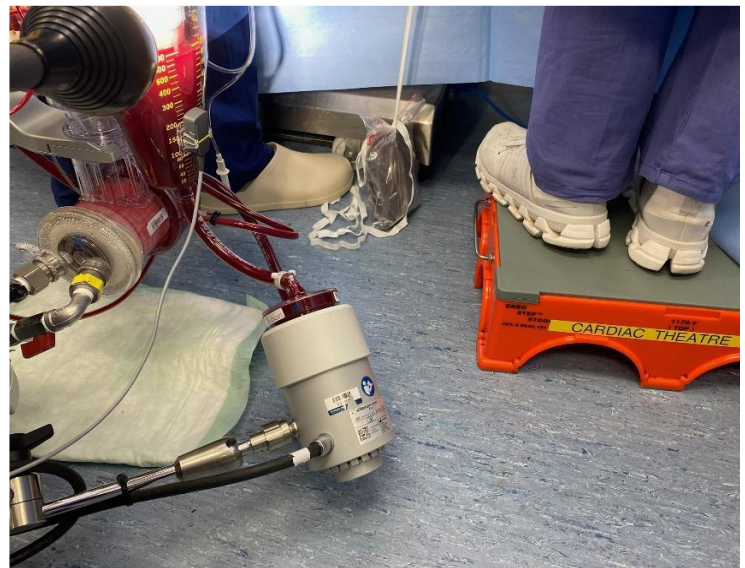
Description: The unit i work in is a training unit and we recently had a couple of new cardiac surgical registrars start. During cases it is not unusual for the consultant and registrar to swap sides several times during the case as part of the teaching process. During an elective CABG case (using an Essenz HLM with centrifugal arterial pump) approximately one hour into bypass at 34oC at steady state the registrar was returning to the assistant side of the table for the third time - there was a step being used and somehow during the moving into position the shoe/foot of the registrar hit the centrifugal pump in the exact spot that caused an uncoupling to occur. The no flow/negative flow alarm sounded and arterial clamp activated. But the noise it makes when decoupled was what I heard first as I saw the registrar's foot suddenly appear and almost kick backwards. I recognised what had happened immediately as it's a very distinct sound when the centrifugal pump uncouples. I was able to place it back and it was only a matter of 20 seconds or so until full flow was returned. I had never seen this happen during a bypass case and am always watchful of the coming and going of surgeons near the pump. In hindsight it is likely that the foot by chance precisely knocked the pumphead retaining clip - see second photo.

Although disconnection of a centrifugal pump from its driver has previously been reported during ECMO transfers, this is the first instance reported to PIRS2 of such an event occurring during CPB. The potential risks associated with reducing HLM circuit volume—whether through shortened tubing or, as in this case, positioning the circuit in close proximity to the patient—highlight the ongoing need for vigilance in circuit layout and configuration. **PIRS Editorial Team**

What could we do better Perhaps chatting to new staff and reminding them to take extra care around equipment - especially when swapping sides and using steps.

Preventive actions Extra vigilance when surgeons are swapping sides and using steps - optimal positioning of equipment where possible - further away from feet and steps, reminding staff to take care near pump and consumables
