# 2026 Leaking ECMO Oxygenator

Category Consumables

Severity Good Catch No Harm Incident

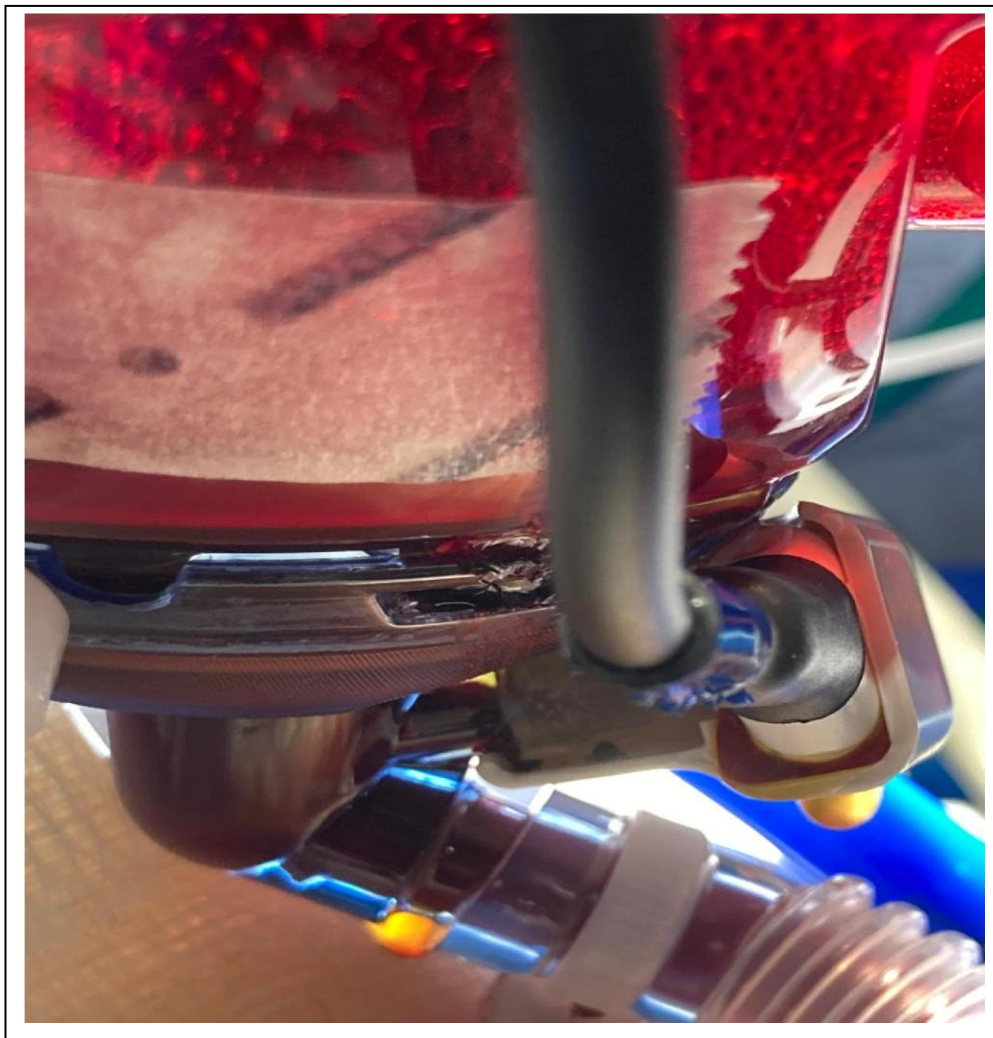
**Description:** Over a four-month period, three separate blood leak incidents were observed involving the Eurosets ECMOLife NB ECMO Oxygenator. Incident 1: Immediately after initiating ECMO support, blood droplets were seen emerging from the bottom of the oxygenator and exiting through the venting holes at the base of the plastic housing. Support was discontinued, and the entire circuit was replaced. Incident 2: During the initial clear prime of a new circuit, a leak was again identified at the same location as in the first incident. The circuit was discarded prior to patient use. Incident 3: One week after the second event, a third leak occurred. The patient had been on ECMO support for approximately six hours when the bedside nurse notified the Perfusion team of blood droplets at the base of the oxygenator. Inspection confirmed the leak originated from the same site as the previous two incidents. Support was stopped and the circuit was replaced.

Blood leak visible in attached photo. Movie of fluid leak during priming attached to email.

**Preventive actions** The distributor has now replaced all circuits with units from a new lot number. Further communication revealed that a manufacturing process change had been implemented approximately 18 months ago to address previously identified oxygenator leak concerns. All future circuits supplied to us will be from this updated manufacturing process. Internally, we have discussed the potential need to pressure test all ECMO oxygenators prior to use, similar to our practice in the bypass setting. Although the manufacturer has advised that such testing is not necessary, we are continuing to evaluate whether adopting this additional step would enhance safety
