## 2026 Oxygenator fibre leak

| Category | Disposable Failure |
| Category 2 | Oxygenator |

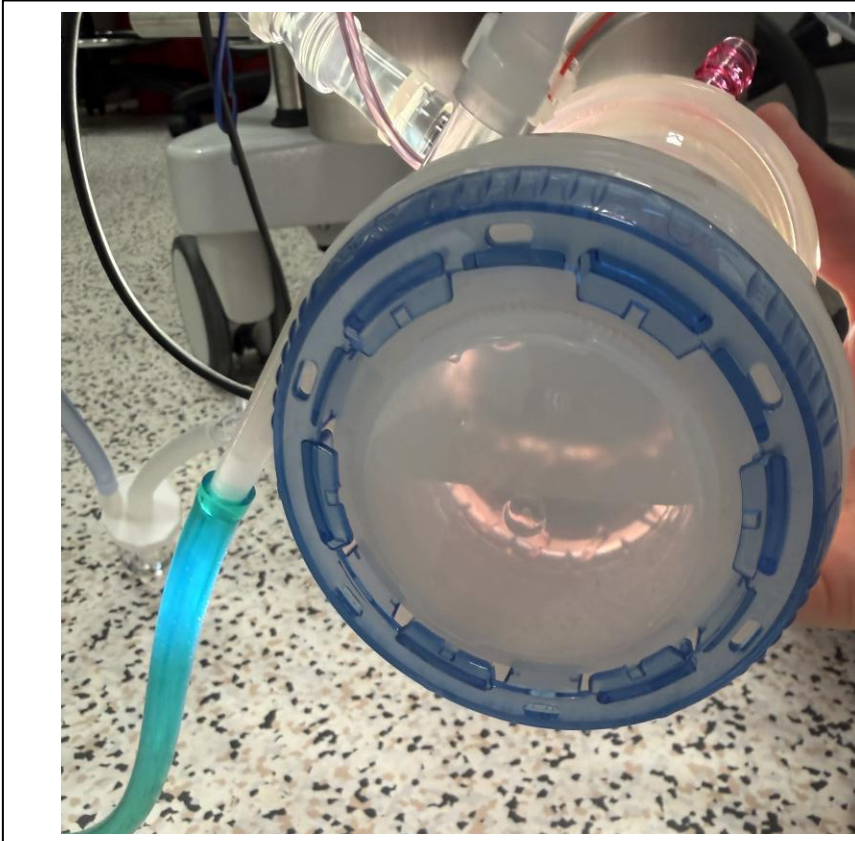
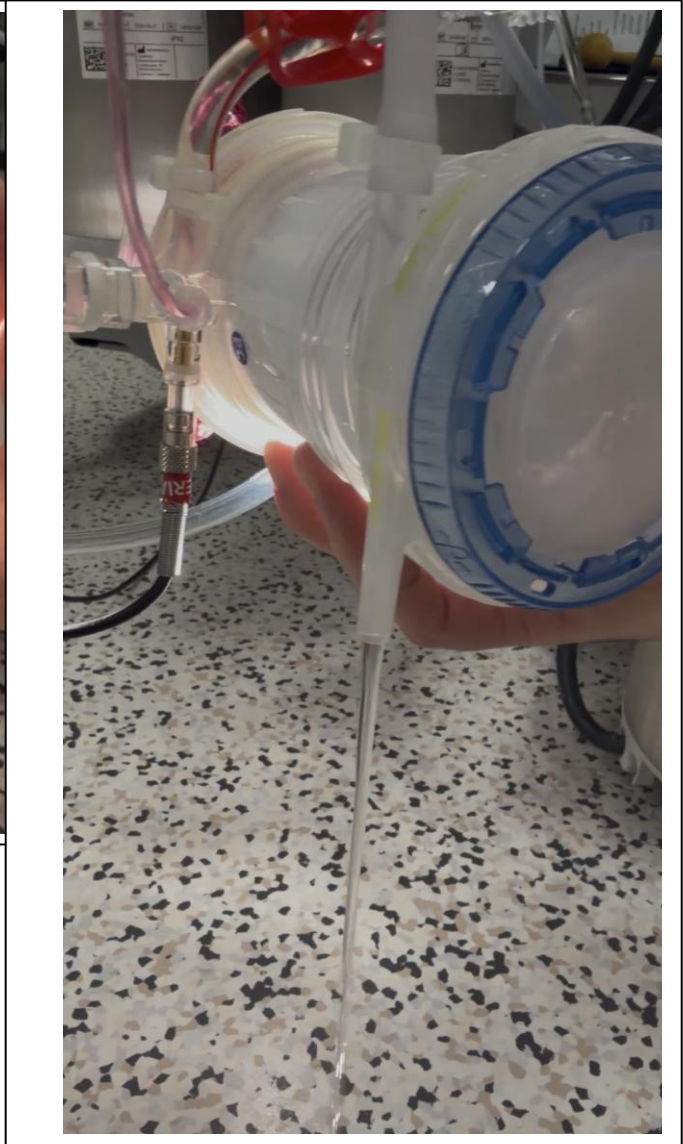
| Description: | <p>Eurosets Trily Pediatric oxygenator, primed on the morning of the procedure. EUROSETS REF AG5232 SN 11914704F0177. Testing occlusions, the arterial pressure was falling by 1mmHg every 2 seconds unchanged by tightening the arterial occlusions. The cardioplegia line was already clamped off. Shunts checked and clamped - continued to lose pressure at the same rate. All clamps rechecked/replaced with no improvement. Arterial boot clamped out - no change. Checked under the oxygenator for leaking, cable tied a small leak on a shunt line- no change (incidental). At this stage I called a more senior staff member for a fresh set of eyes/more ideas thinking something simple had been missed. He suggested checking the transducer and came to help. Transducer replaced - functioning well. All shunts were rechecked, they then clamped the arterial outlet isolating the oxygenator from the transducer which stopped the pressure loss. We discussed options and then he decided to pressure test the heater cooler ports again (normally done on setup) - no leak. We then checked the gas phase by inverting the oxygenator (taking it out of the holder and tipping it around 90 degrees as per attached photos show) and crystalloid poured out of the gas port. We changed the oxygenator, notified our department and the supplier, isolated the same Lot numbers from our stock.</p> |
| Commentary | <p>This was a great catch by the primary perfusionist and good support from the N +1 to help problem solve. The photo shows how significant the leak was and picking it up prior to the case starting was the best outcome. We note that the practice of isolating the oxygenator under pressure to check for a fibre leak was not uniformly practiced which underscores the value of standardising procedures. While testing for heat exchanger</p> |

water leaks is routine, testing for oxygenator fibre leak may be less common. Of interest PIRS2 has never received a report of a heat exchanger leak, however, reports of fibre leak are not uncommon, hence routine testing is warranted. PIRS Editors.

| Preventive actions | <p>Supplier contacted &amp; Team aware of the problem. Stock with the same batch number quarantined.</p> |
