2022 servoregulation

Permission to print: Yes
Category Pump Servoregulation
Incident type Good Catch No Harm Incident
Duration of incident: minutes

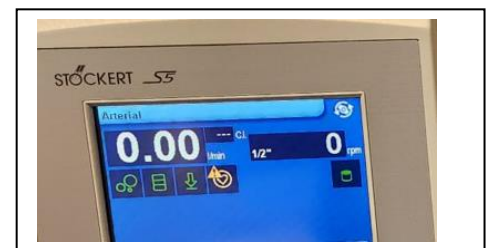
The background to this was, about a week or two, we were advised that all our machines are getting new software updated and this software will have a few extra features. Having this background knowledge, I assumed this additional safety feature was due to the recent software upgrade. To further strengthen my assumption, I asked one of my colleagues what this other safety icon meant in the main arterial display. Again, she confirmed that it was very likely a new software update. I usually keep the main arterial pump running, with the cardioplegia pump in recirculation mode, until we hand off the lines. Once heparin was given, I turned my pump off and did my occlusion tests with a scrub nurse dividing the lines. Everything was going as planned. Once the patient was cannulated and connected to the bypass machine after achieving the required ACT, the bypass was commenced. Everything was going as planned; I started the cardioplegia pump and deaired the cardioplegia line towards the table while the cardioplegia display was in recirculation mode. Once the surgeon cross-clamped the aorta, I turned the pump down, pressed the x-clamp timer, and simultaneously delivered cardioplegia. All was going well, the heart was arrested, and the intracardiac temperature decreased rapidly to the desired temperature. Although the amount of cardioplegia delivered on display looked a bit odd, showing a delivered 21.76 litres of cardioplegia, I thought I may not have pressed delivery on time and ended up calculating it manually, turned the cardioplegia delivery off at the end of the total dose. Once I turned my cardioplegia delivery off, it turned my main arterial pump off. I could not understand what had happened for a second, so I immediately bypassed the pump's safety features [double hand icon on S5] and kept it running. The perfusion coordinator and a second colleague immediately came to the OR to assist. While the pump was running, I investigated if any error was displayed. No error message was displayed on the panel; however, the only indication was the orange icon on the main arterial pump (fourth feature).

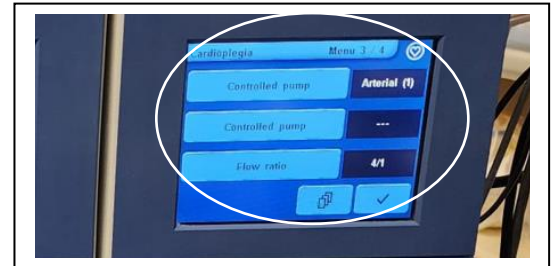
I ensured the bypass was running smoothly and called for help. The biomedical engineer was called, and she could not find anything wrong with the pump or the settings as all settings were as expected, according to her. She did some troubleshooting while I was on bypass. Still, every time I deactivate the bypass safety feature, the pump will stop, with an activated orange light icon on the main arterial display. We could not understand what was happening as all the

settings, including stop link settings, were correct. I decided to continue bypass with safety features turned off while help staff were trying to figure out what was going on. The biomedical engineer checked the settings of the other S5 pumps in the perfusion room and found out where the problem was (see below). Once the settings for the cardioplegia pump were replicated to the other HLM settings, the extra icon on the main display disappeared. I reactivated the safety features and the pump did not stop. This solved the problem, and the rest of the case continued without any pump issues. During the annual maintenance of the S5 pump, the settings on the cardioplegia pump were changed or defaulted, creating a link between arterial and cardioplegia pumps. This resulted in the cardioplegia pump controlling the main arterial pump. When the cardioplegia pump was on, the main arterial pump would work, but when you turned it off, it would also turn off the main arterial pump and activate the safety icon on the main display. Once we changed the name of the cardioplegia pump to cardioplegia 2a, the icon disappeared from the main display, and everything went normal.

What could we do better A detailed post maintenance functional checklist as a change in practice. As we do not have anything currently in place.

Preventive actions institute a detailed post maintenance functional checklist on receipt of the HLM prior to the HLM approved for use. Also the standard HLM checklist to include additional check on servoregulation sub settings.
