2024 Gas supply - Personnel injury

Category Gas Supply

Category 2 Personnel injury

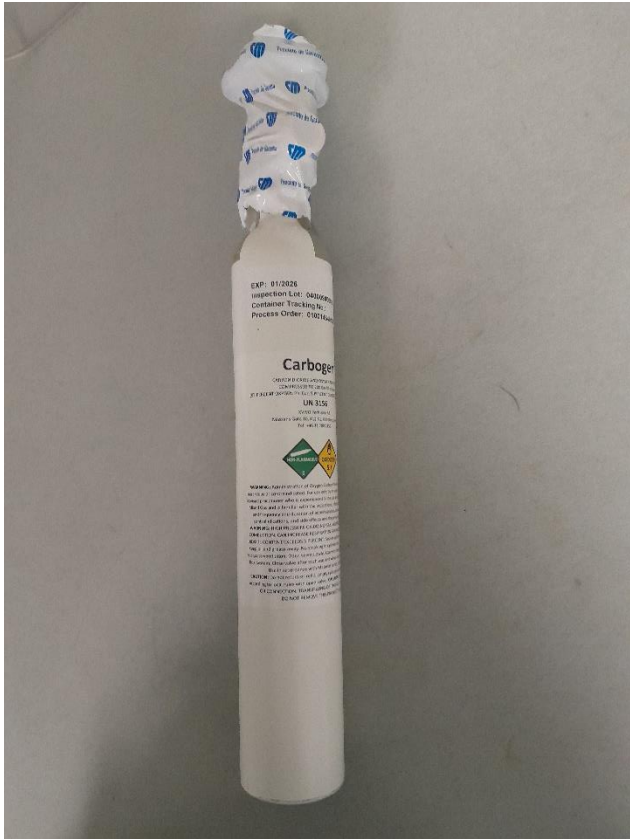
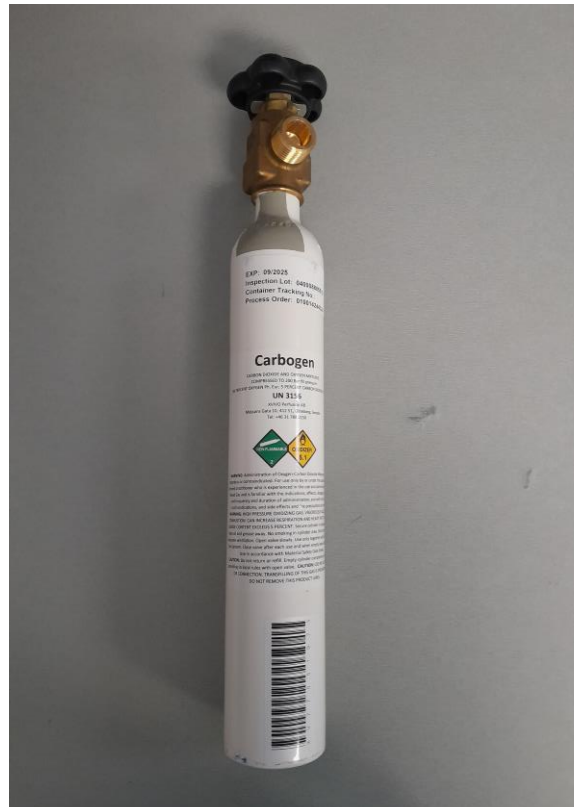
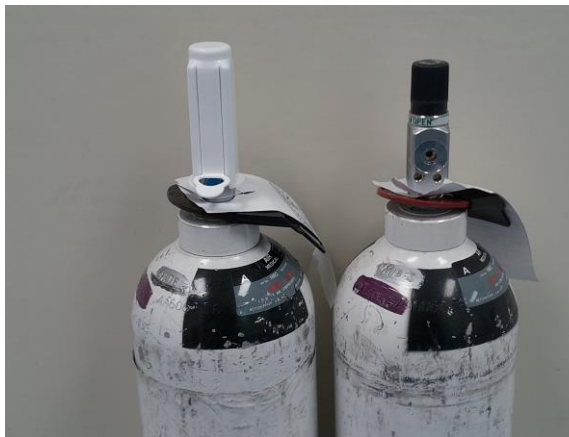
Description: Incident Harm to perfusionist (not patient). Attempting to take of the 'Opaque' plastic shrink wrap off a new full 200 Bar carbogen compressed gas cylinder valve system for the XVIVO Heart in The Box, the contents of the gas exploded in my face. I was dazed, shocked, with vision blurred, ringing in my ears, chest wall pain and symptoms of concussion. No one came to investigate the explosion or assist me, but I eventually wandered into adjacent room and informed another staff member of incident. A Hospital risk management incident report was made. The company was notified as were other staff that had not witnessed or aware of all details of the incident. The incident is yet to be reported to the regulatory authority. The XVIVO website states: CAUTION: The XVIVO Heart Technology is not regulatory approved on any market and its safety and efficacy has not been established. The XVIVO Heart Technology is not commercially available. The Heart in the box Cylinder shrink wrap cover is 'Opaque', so personnel are unable to readily visualize the valve outlet to point away from face, other personnel or equipment. The valve plastic shrink wrap has no tear tag or serrated tear line that could be visualized which could make it easier to remove the plastic shrink wrap cover. Pulling the shrink wrap to tear it off, seems to have caused the Gas Cylinder Valve Hand wheel (which is permanently fixed to the cylinder) to open.

What could we do better Design improvements. A transparent plastic shrink wrap seal would allow the valve outlet to be visualized and pointed away from face, other personnel, or equipment. Nitric Oxide has a similar valve hand wheel and valve outlet system, but has a transparent plastic shrink wrap around the valve system, which allows for clear visualization of the valve outlet and other components. The Nitric Oxide cylinder valve outlet has a seal cap (the XVIVO carbogen cylinder does not) over the valve outlet that consists of Nut, Cap, Gasket and Chain, (however this is not designed to contain full cylinder pressure). Medical air and oxygen cylinders have a seal that does not enclose the opening valve and the valve indicates the open and close directions that the XVIVO carbogen bottle does not.

Medical air cylinder with tear tab

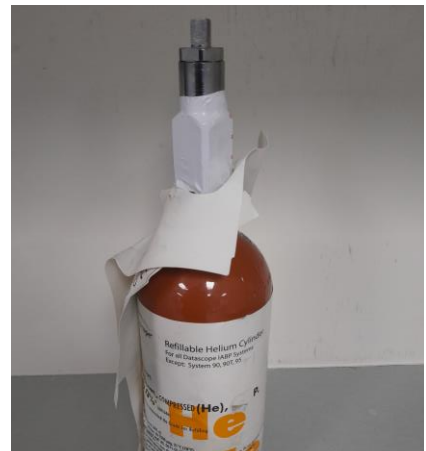
Helium cylinder with exposed valve
